# Juniper Networks Release Notes

Product: Juniper Networks ISG-1000 and Juniper Networks ISG-2000

Version: ScreenOS 5.0.0r10

Part Number: 093-1766-000, Rev. A

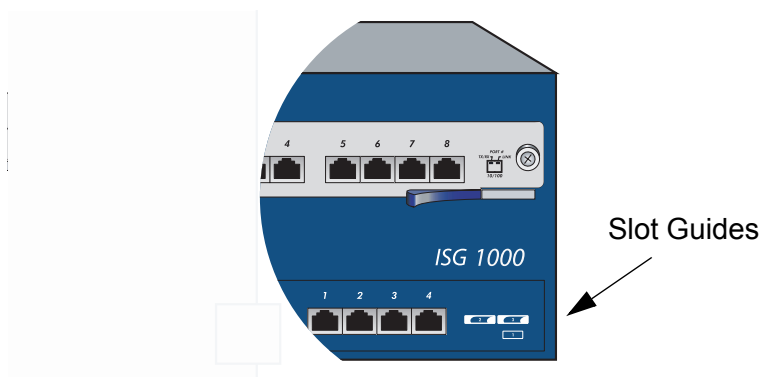
The slot guides shown in all of the illustrations of the ISG 1000 chassis in the *ISG 1000 User's Guide*, are inaccurate. Three slot guides should appear in the bottom right-hand corner on the front panel of the chassis to aid the system administrator with port numbering. The following illustrations show the correct slot guides.

Slot guide 1 represents the four built-in ports, slot guide 2 represents the module in the upper left-hand corner of the chassis, and slot guide 3 represents the module in the upper right-hand corner of the chassis.
