Release Notes: Junos[®] OS Release 15.1X49-D80 for the SRX Series

Release 15.1X49-D80
30 May 2017
Revision 4

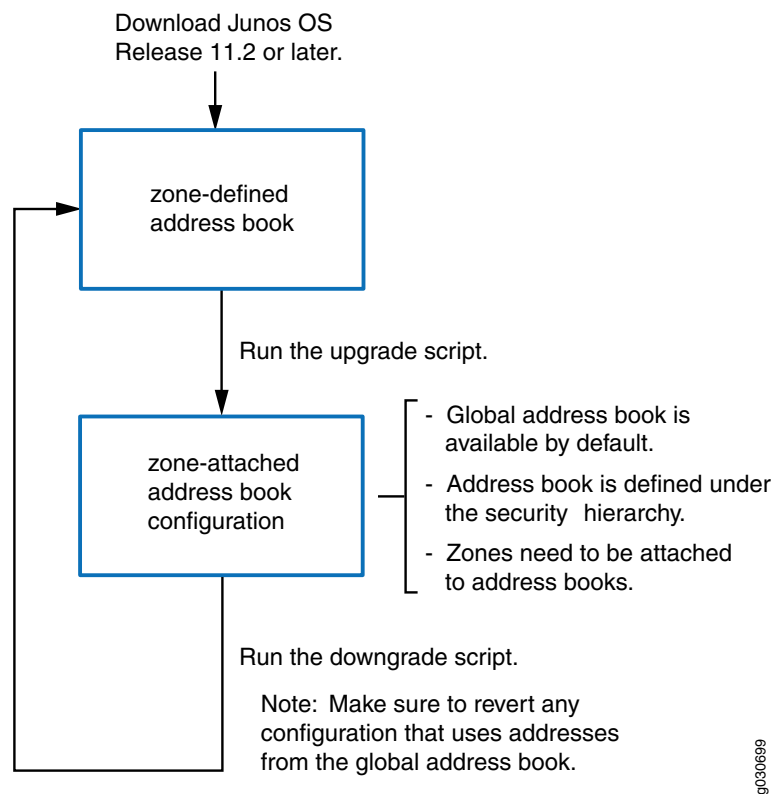
Figure 1: Upgrade and Downgrade Scripts for Address Books

Juniper Networks provides Junos operation scripts that allow you to work in either of the address book configuration formats (see [Figure 1 on page 32](#)).

NOTE: Before running the downgrade script, make sure to revert any configuration that uses addresses from the global address book.
