BTI 7000 Series Alarm and Troubleshooting Guide

Part Number: BT7A74DA
Document Version: 01
Published: March 2017
Type: STANDARD

product release 13.5

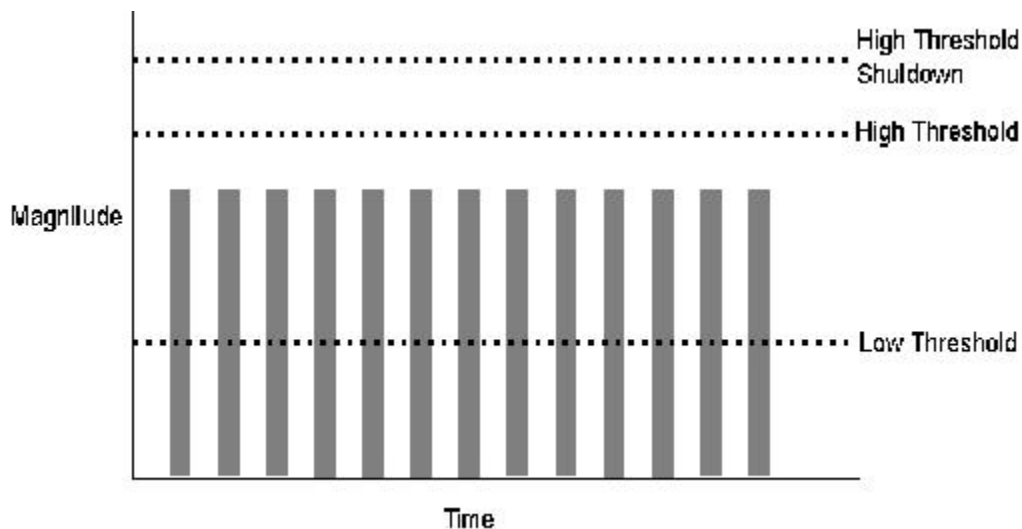
Figure 2-1 Example of Typical Alarm Thresholds

The following figure shows a generic example of typical thresholds for a monitored value and how the normal operating range is within the designated thresholds.

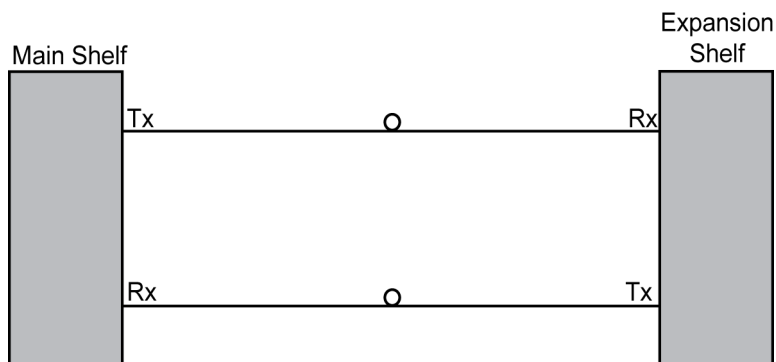
Figure 2-10 Fiber optic links between the BTI 7000 Series main shelf and a remote expansion shelf

The following illustration shows the fiber optic links that are present between a BTI 7000 Series main shelf and a remote expansion shelf.

If a fault occurs between the main shelf SFP transmitter and the remote expansion shelf SFP receiver, an EXPSHCOMLNKDWN alarm occurs.

If a fault occurs between the remote expansion shelf SFP transmitter and the main shelf SFP receiver, then both an EXPSHCOMLNKDWN alarm and a LOS alarm occurs.

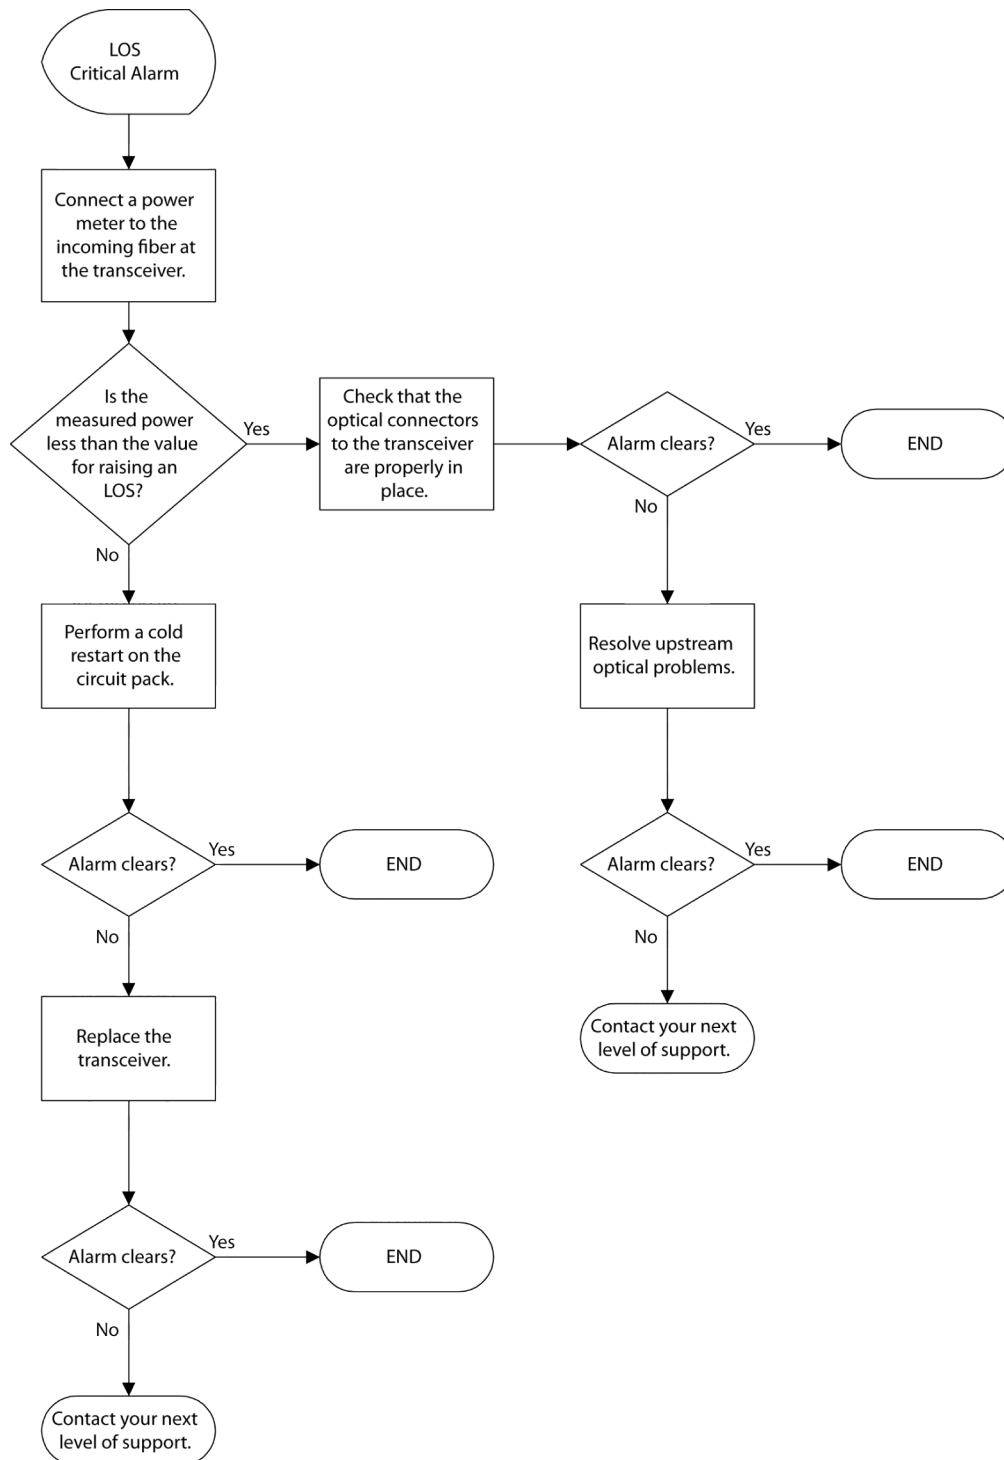
Figure 2-26 Clearing an LOS alarm

The following figure shows a flow chart of the activities that can be part of this alarm clearing procedure. Use the flow chart to understand the context of the alarm. Use the procedure to clear the alarm.

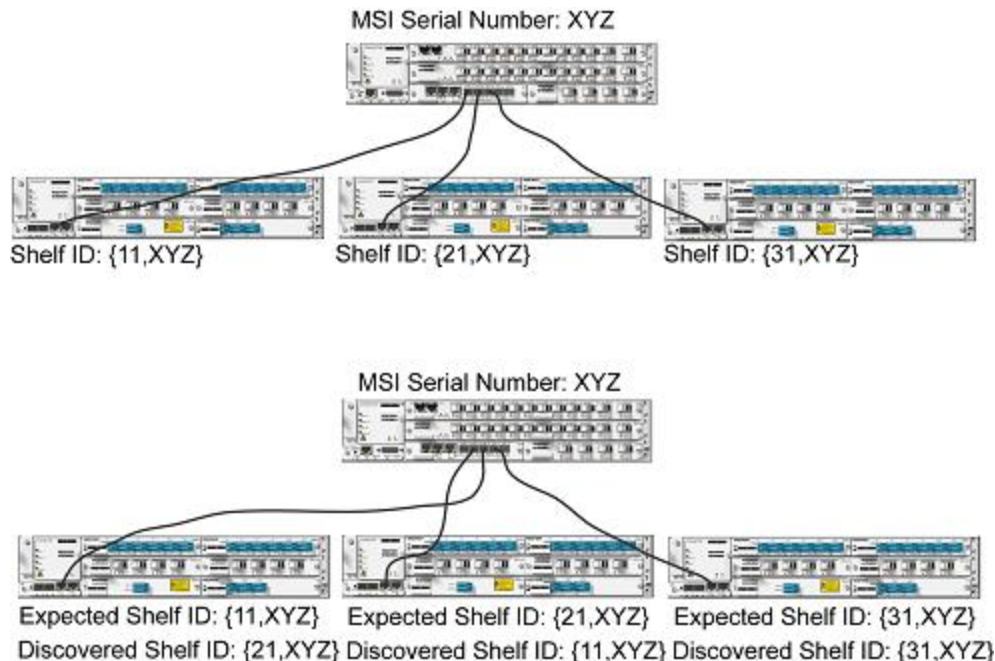
Figure 2-36 Scenario 1: The expansion shelf cables are swapped

In this scenario, the expansion shelf cables that are connected to the SCP circuit pack in the main shelf acquire expansion shelf IDs that are based on the order in which they are originally provisioned. Subsequently, the expansion shelf cables from expansion shelves 11 and 21 are reconnected in a reverse sequence. As a result, the BTI 7060 expects shelf IDs that are different from the discovered shelf IDs. This causes the REPLUNITIDMEA alarm to be triggered.

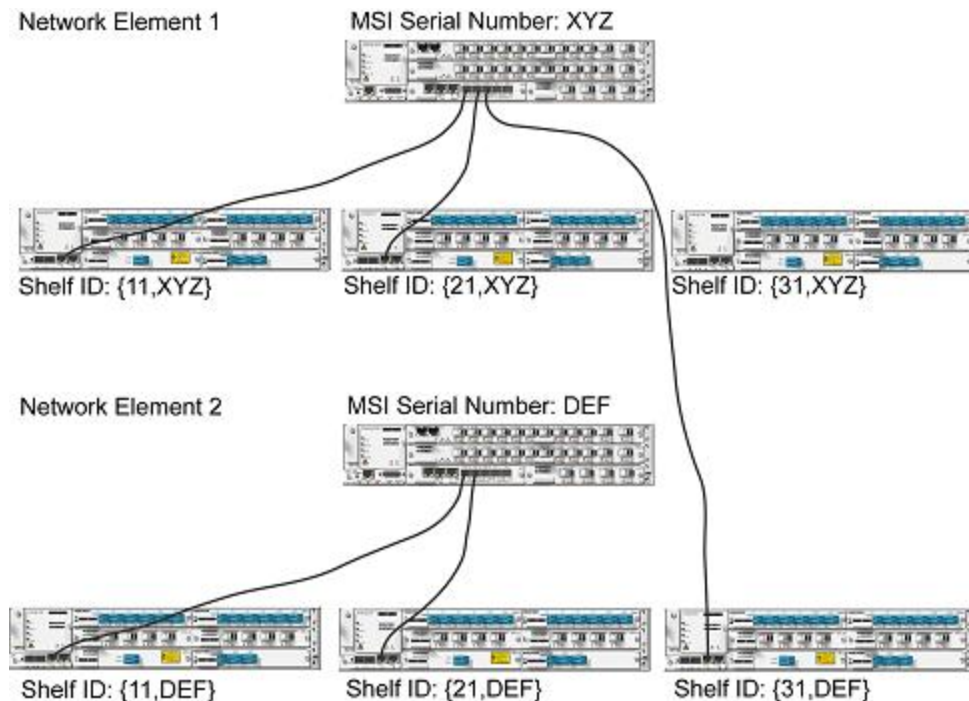
Figure 2-37 Scenario 2: An expansion shelf from another NE is incorrectly connected

- 2 The expansion shelf from another network element (NE) is connected to an expansion shelf port on the SCP of the first system.

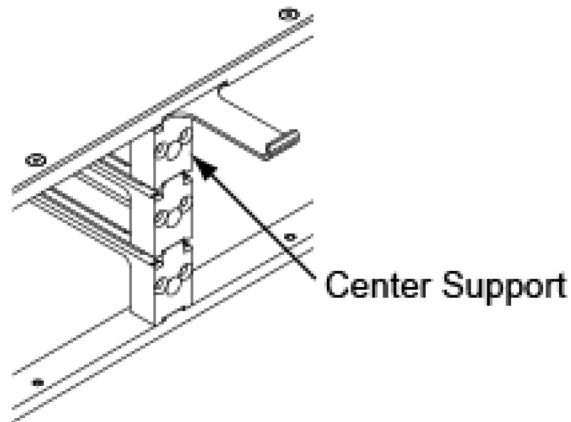
Version 1 of the center supports has a hole at the front of the center support through which a screwdriver is used to access the rear-mounted fastener.

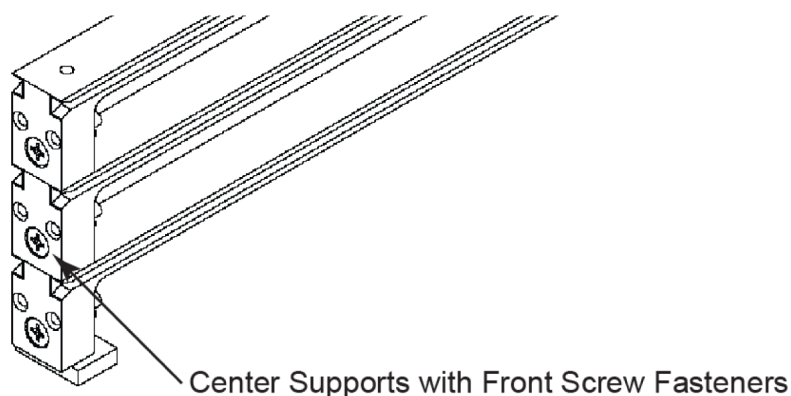
Version 2 of the center supports has a screw fastener at the front of the center support.

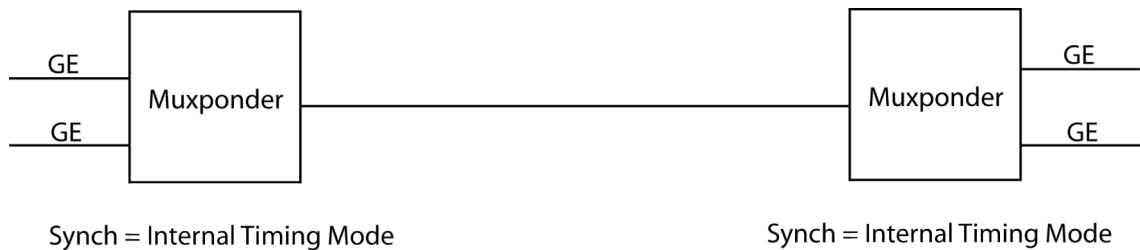
Default Synchronization Settings

The default synchronization setting for two muxponders connected directly to each other is to run both units on the internal timing mode.

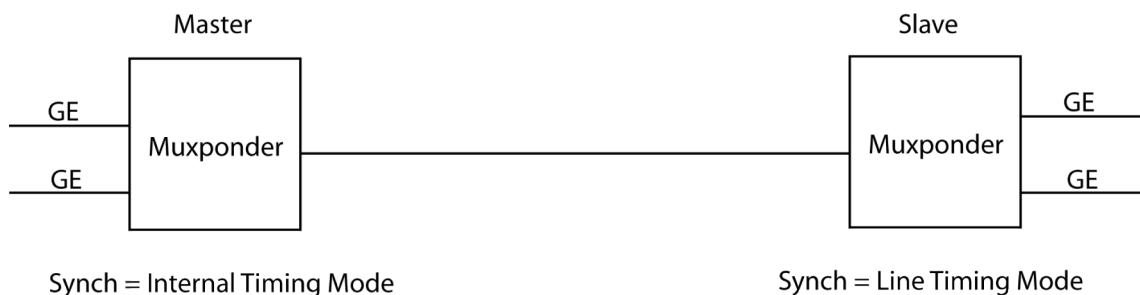
Master/Slave Synchronization Settings

The master and slave synchronization setting for two muxponders connected directly to each other is to run one unit as the master using the internal timing mode, while the other unit is run as the slave using the line timing mode.

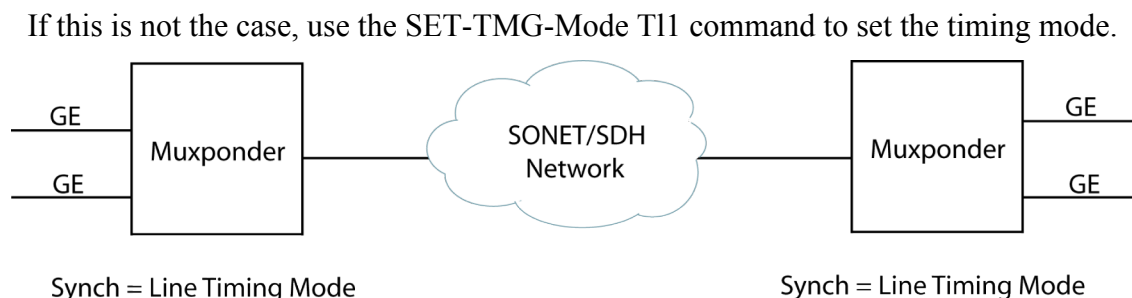
SONET/SDH Synchronization Settings

The default synchronization setting for two muxponders connected to each other through either a SONET or SDH network is to run both units on the line timing mode thereby acquiring synchronization from the network.

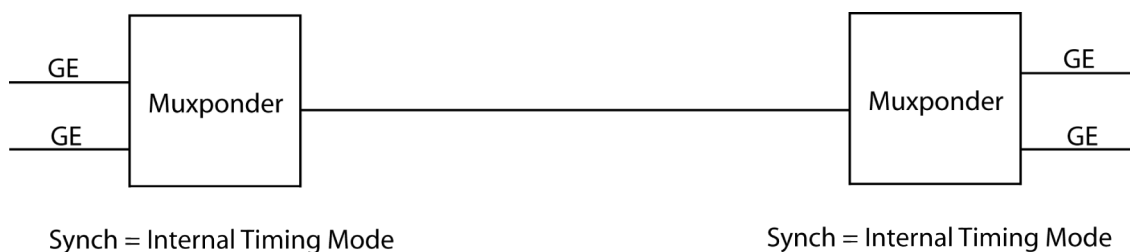
Default Synchronization Settings

The default synchronization setting for two muxponders connected directly to each other is to run both units on the internal timing mode.

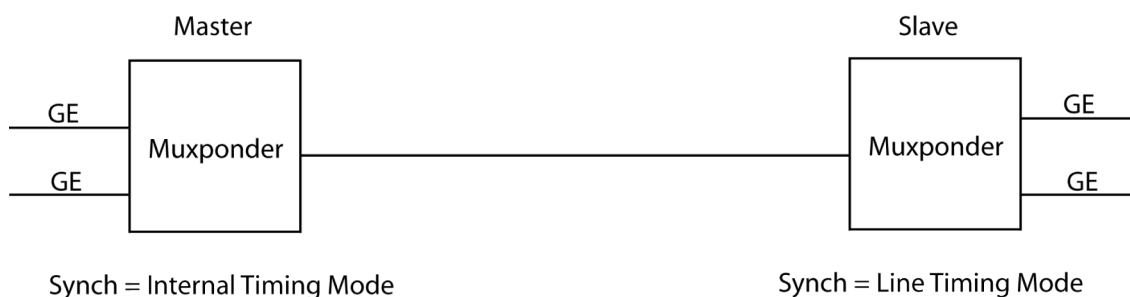
Master/Slave Synchronization Settings

The master and slave synchronization setting for two muxponders connected directly to each other is to run one unit as the master using the internal timing mode, while the other unit is run as the slave using the line timing mode.

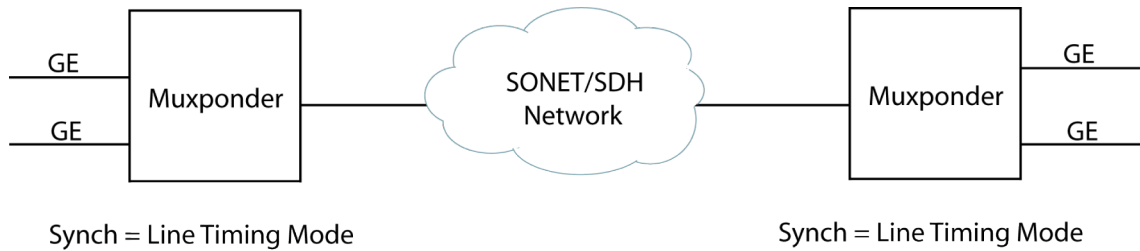
SONET/SDH Synchronization Settings

The default synchronization setting for two muxponders connected to each other through either a SONET or SDH network is to run both units on the line timing mode thereby acquiring synchronization from the network.

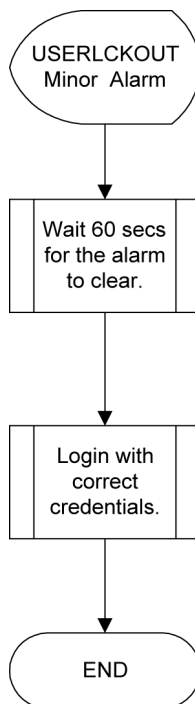
Figure 2-73 Clearing a USRLCKOUT alarm

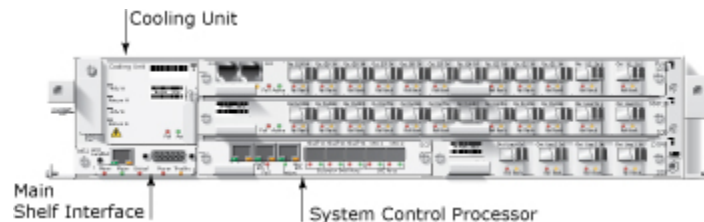
The remaining module slots are located to the right of the MSI, or ESI, and CU. In the main shelf, slot 5 is configured to accept the System Control Processor (SCP) module only, and the remaining slots can be provisioned to accept other modules. In the expansion shelf, all slots to the right of the ESI and CU can be provisioned to accept modules.

Main Shelf Common Equipment Module Locations

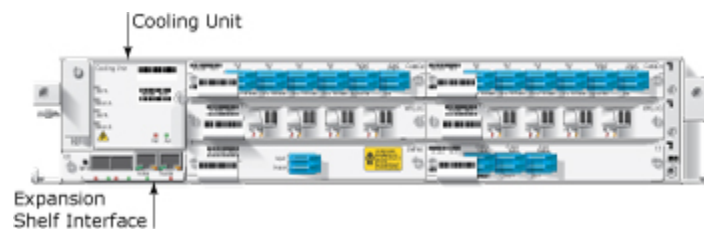
Figure 3-2 Expansion Shelf Common Equipment Module Locations

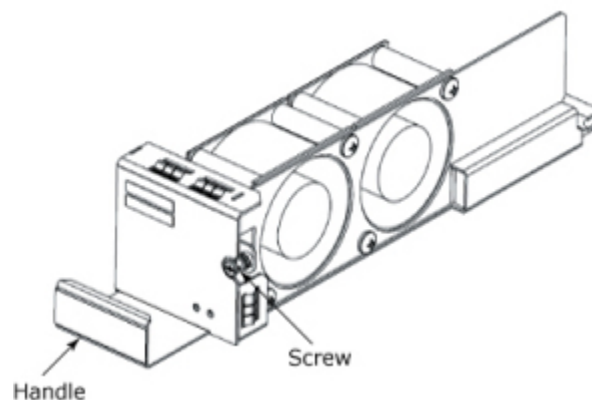
Figure 3-3 BTI 7060 Cooling Unit module

Note The Cooling Unit must be installed in its dedicated slot in the shelf.

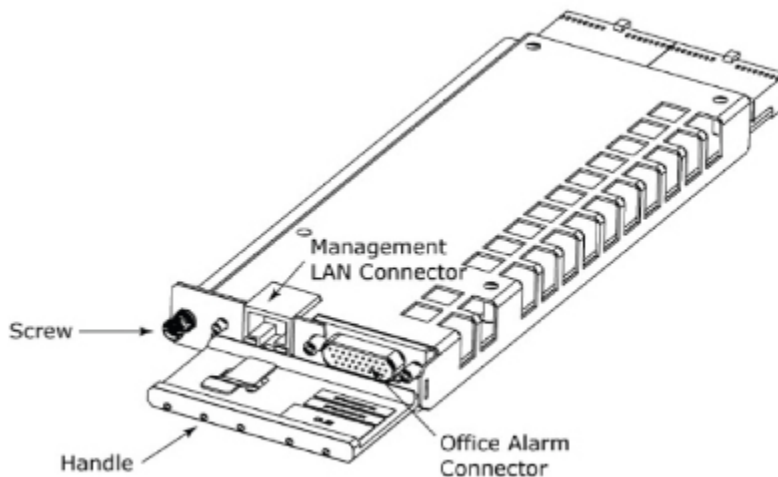
Figure 3-4 BTI 7060 MSI module

Note The MSI module must be installed in its dedicated slot in a main shelf.

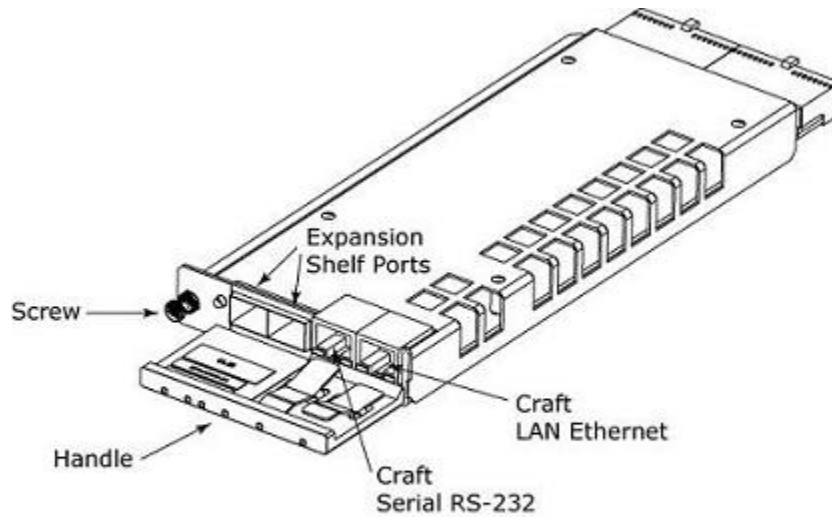
Figure 3-5 BTI 7060 ESI module

Note The ESI module must be installed in its dedicated slot in an expansion shelf.

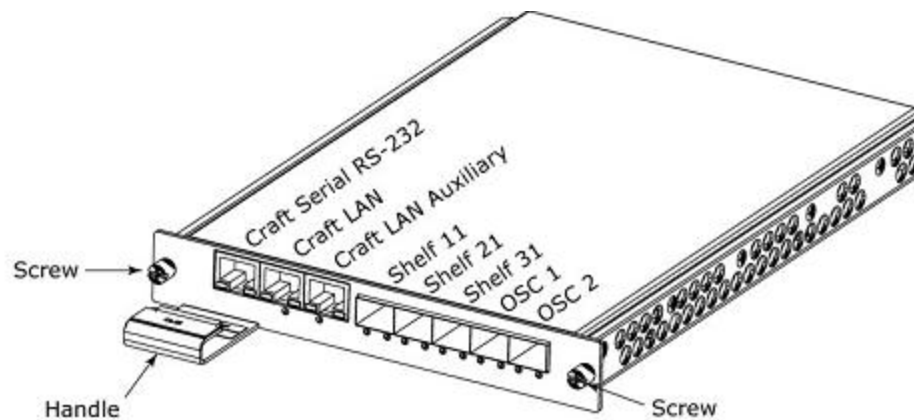
Figure 3-6 SCP module

Note The SCP module must be installed in slot five of the main shelf.

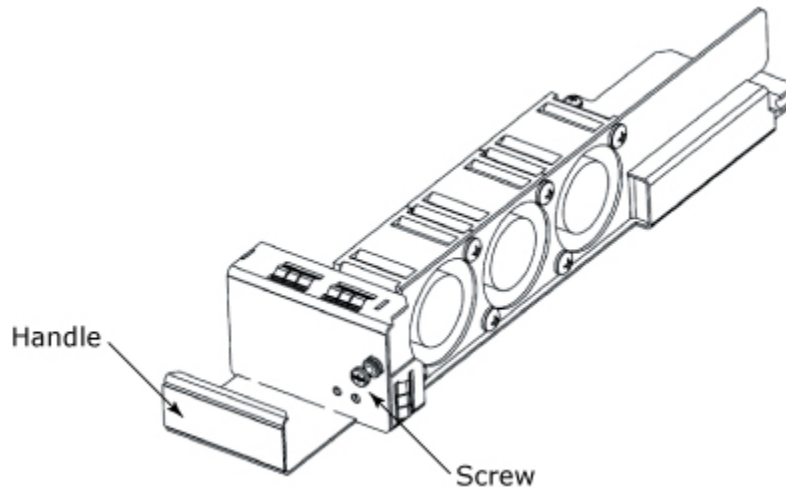
Figure 3-8 BTI 7030 Cooling Unit module

Note The BTI 7030 Cooling Unit module must be installed in its dedicated slot in a BTI 7030 shelf.

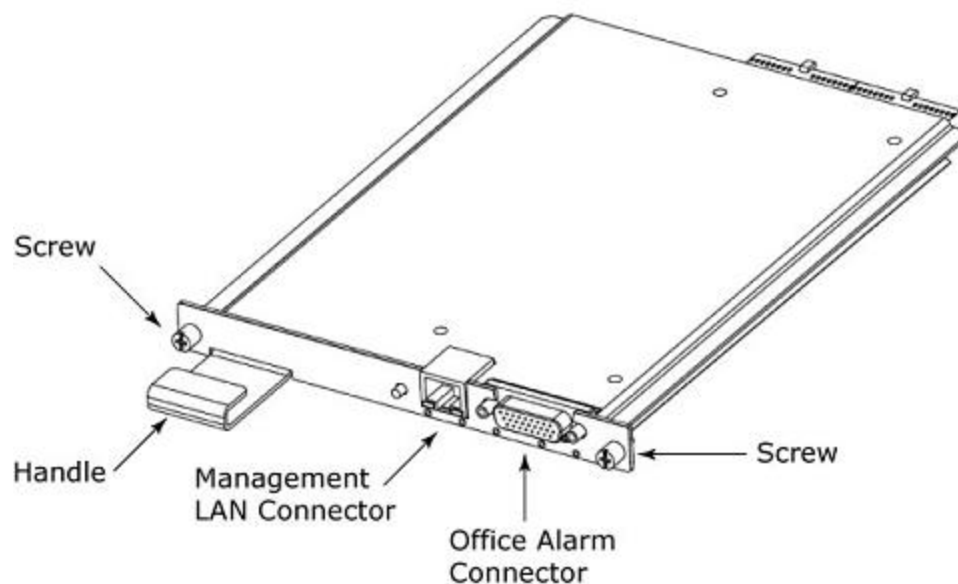
Figure 3-9 BTI 7030 MSI module

Note The BTI 7030 MSI module must be installed in its dedicated slot in a BTI 7030 shelf.

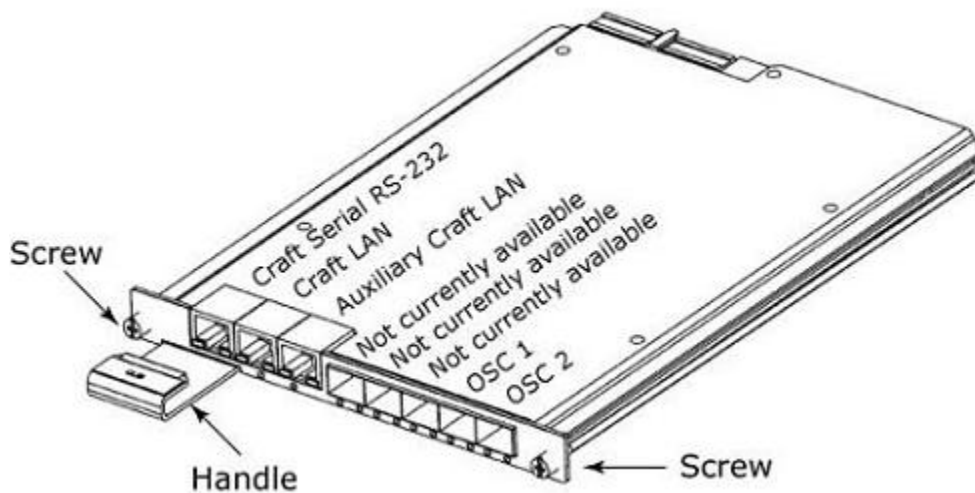
Figure 3-10 BTI 7030 SCP module key features

Note The BTI 7030 SCP module must be installed in its dedicated slot in a BTI 7030 shelf.

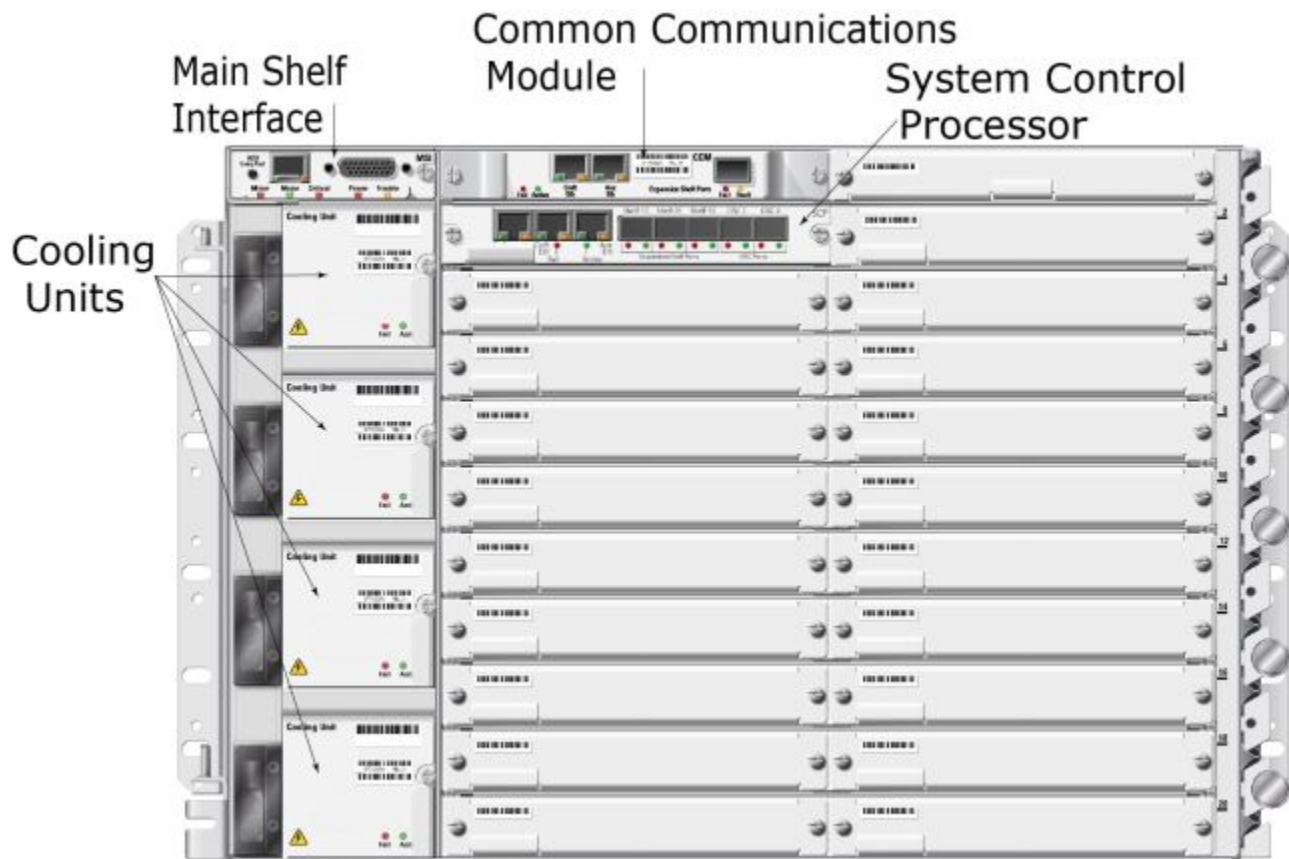
- Where a BTI 7200 is used as a main shelf in a two-shelf configuration, slot 1 is dedicated for the system control processor (SCP) module. All of the remaining slots can be provisioned with any provisionable module.
- Where a BTI 7200 is used as an expansion shelf in a two-shelf configuration, all of the slots can be provisioned with any provisionable module.
- Where a BTI 7200 is used in a restricted three-shelf configuration, main shelf slot 1 is dedicated for the system control processor (SCP) module. All of the remaining slots can be provisioned with up to 40 10G Transponders, up to nine 10G Muxponders, up to nine packetVX, and up to nine ROADM-on-a-blade modules. Muxponders can be substituted with amplifiers, and passive modules.

Main Shelf Common Equipment Module Locations

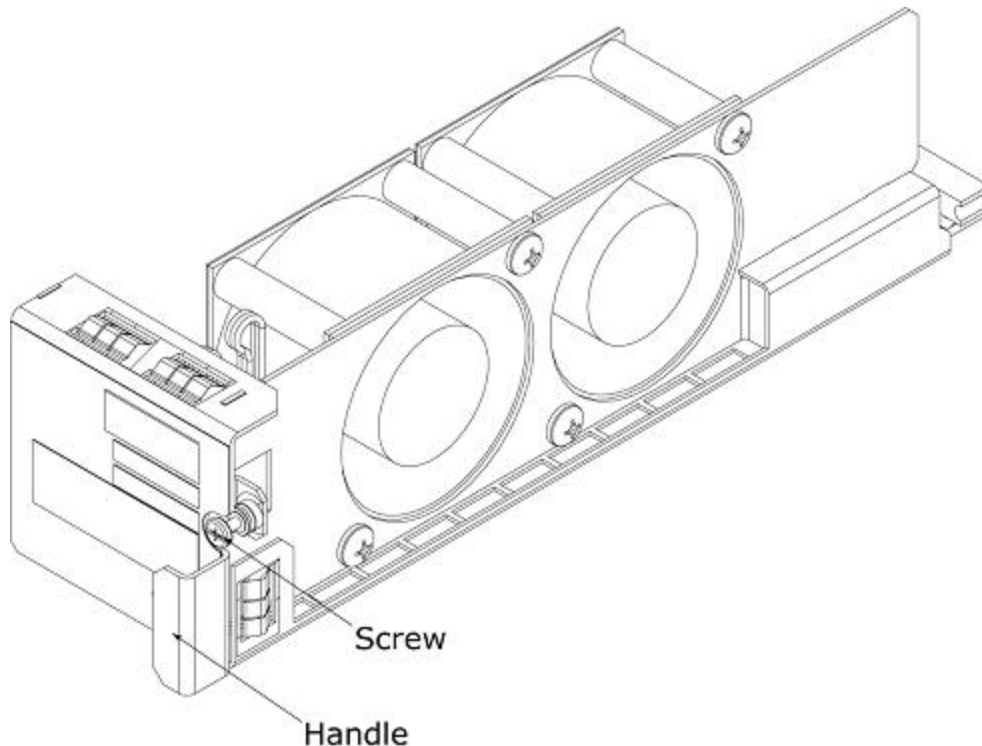
Figure 3-13 BTI 7060/BTI 7200 Cooling Unit module

Note The Cooling Unit must be installed in its dedicated slot in the shelf.

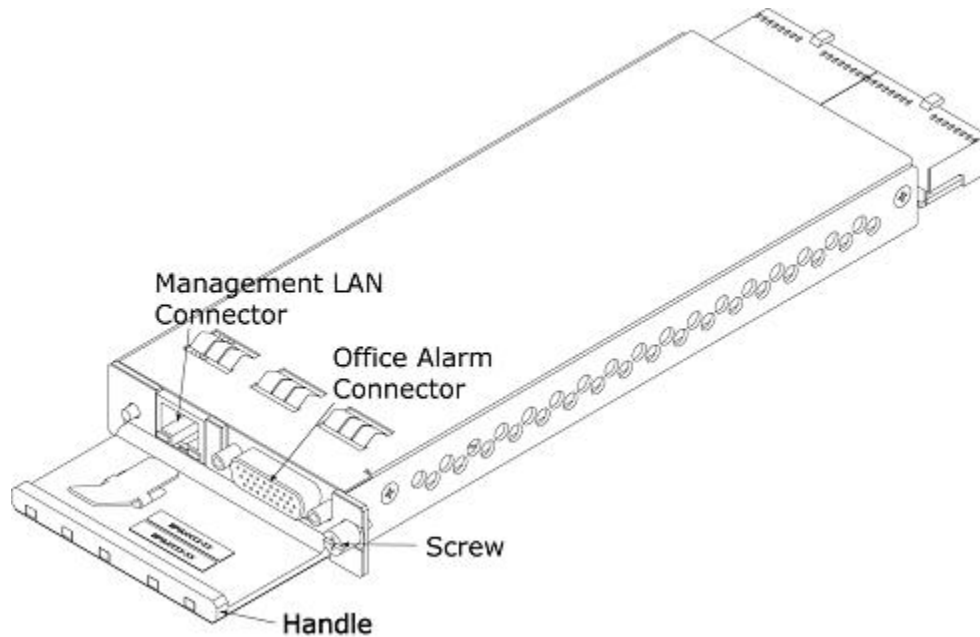
Figure 3-14 BTI 7200 MSI module

Note The MSI module must be installed in its dedicated slot in a main shelf.

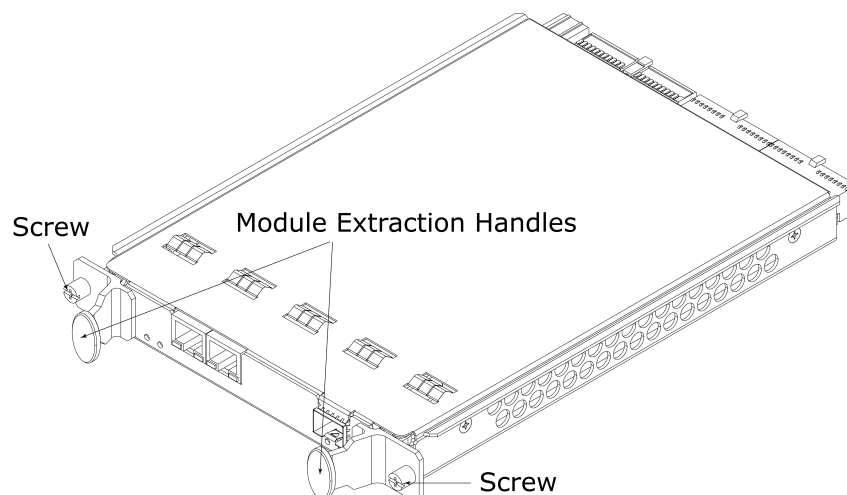
Figure 3-15 BTI 7200 CCM

Note The CCM must be installed in its dedicated slot in a main shelf or an expansion shelf.

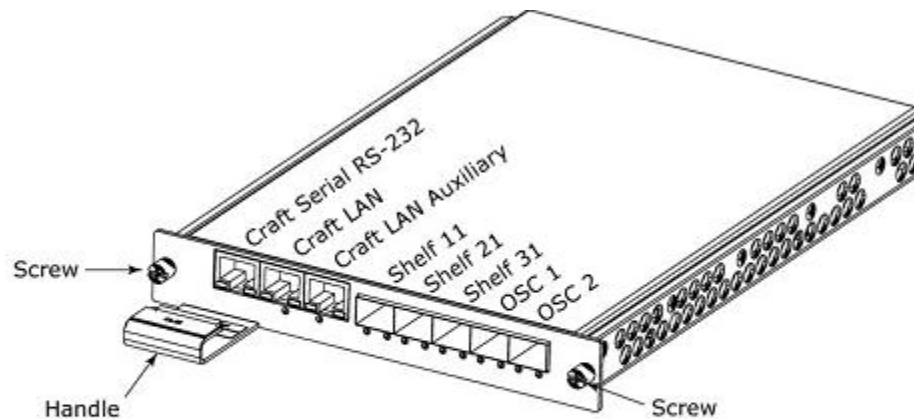
Figure 3-16 SCP module

Note The SCP module must be installed in slot one of the main shelf.

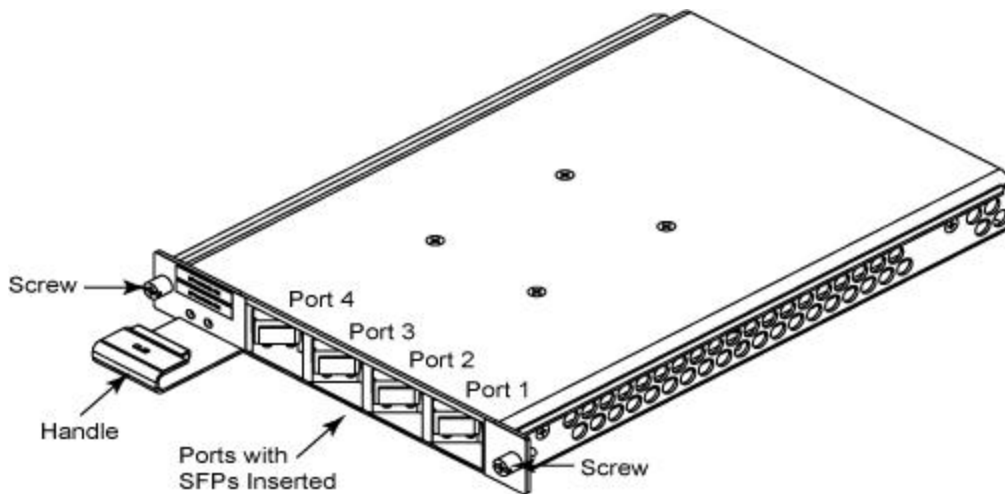
The following figures show the Transponder modules and indicate the key features for replacing them.

Dual 1G and Dual 2.5G Multiprotocol Transponder module

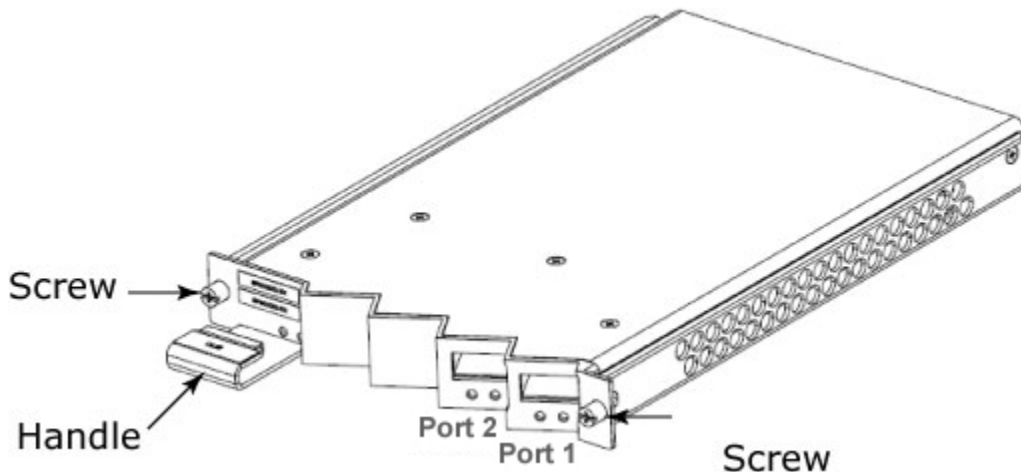
10G Multiprotocol Transponder module

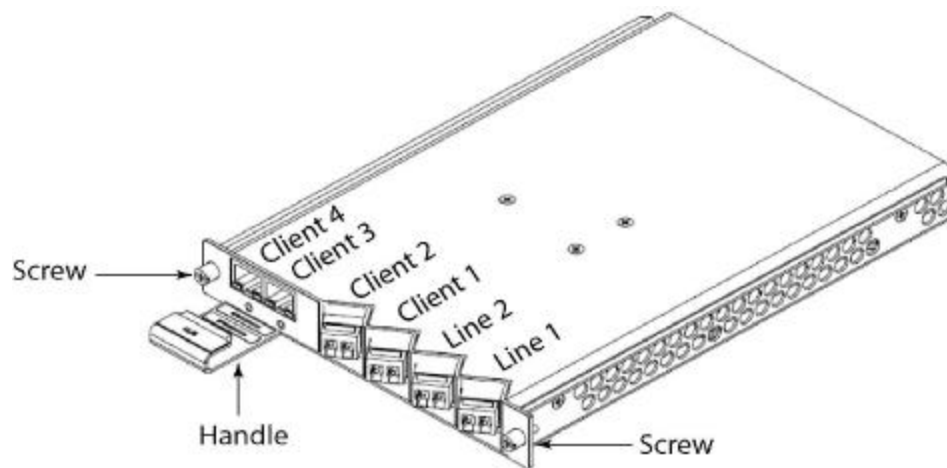
The following figure shows the 2-Port GbE Muxponder module and indicates the key features for replacing it.

2-Port GbE Muxponder module

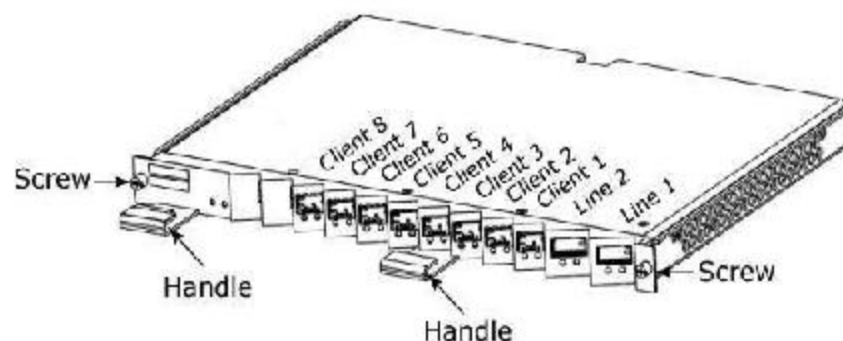
8-Port Multiprotocol Muxponder

The following figures show the 8-Port and 10-Port Multiprotocol Muxponder modules and indicate the key features for replacing these modules.

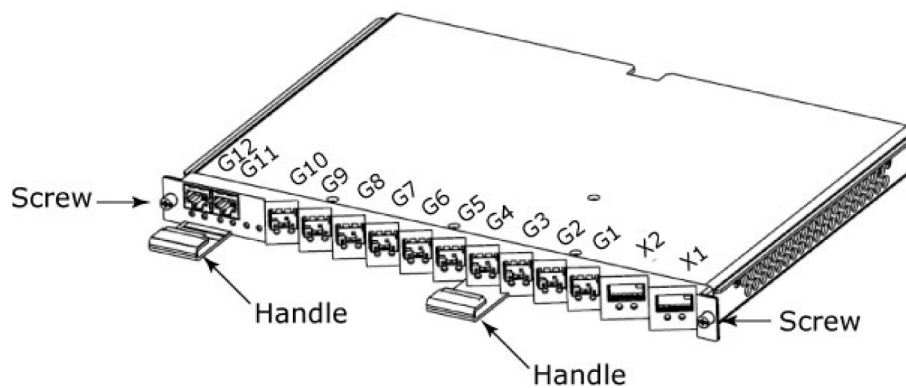
The following figures show the key features of the packetVX modules and indicate the key features for replacing them.

Figure 3-22 packetVX module BT7A81AA 12/2

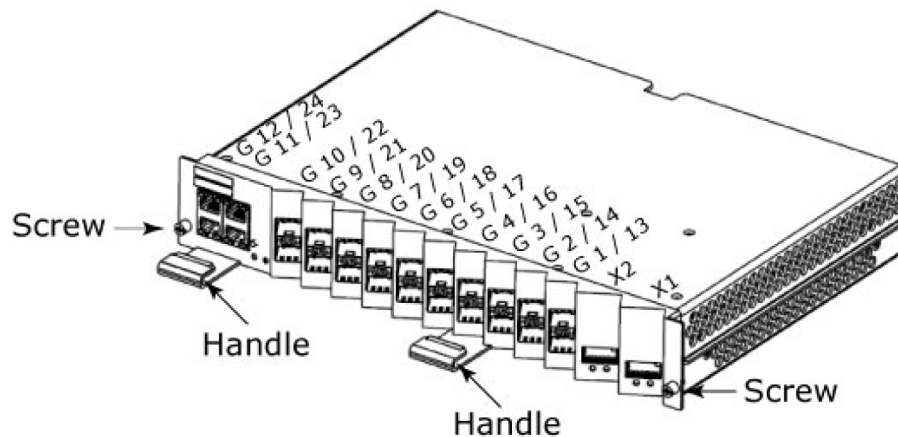
Figure 3-23 packetVX BT7A81BA 24/2 module

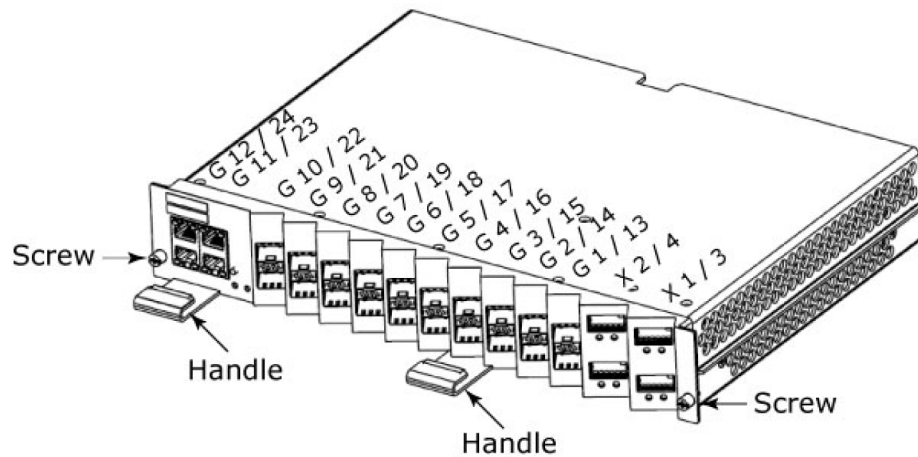
Figure 3-24 packetVX module BT7A81CA 24/4

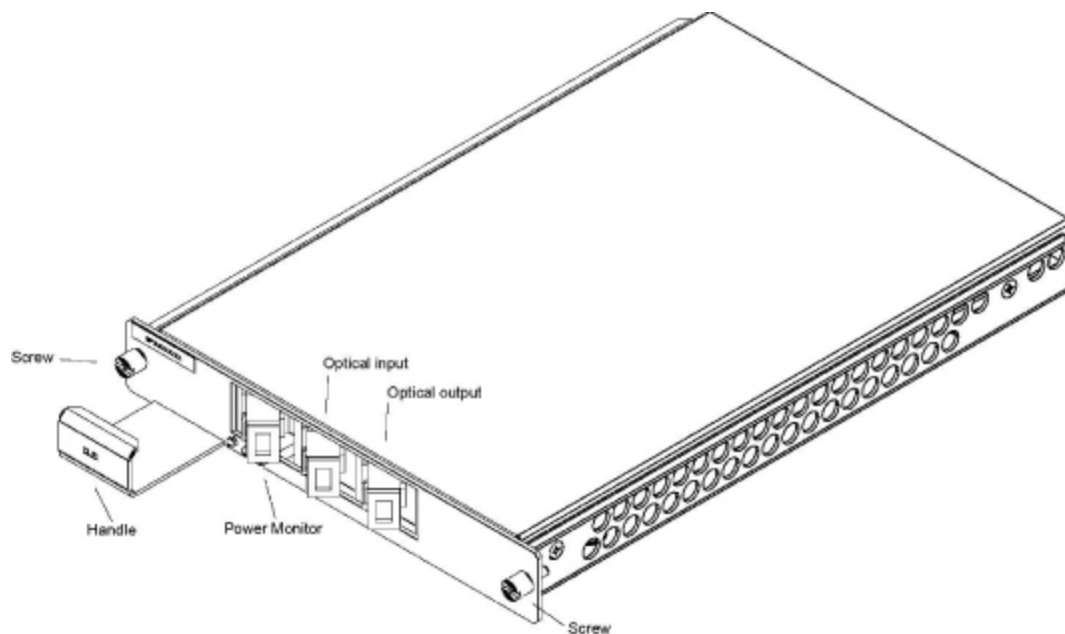
The following figures show typical amplifiers and indicate the key features for replacing them.

Figure 3-25 Single Channel /Sub-Band Amplifiers (SBA) and DWDM C-Band Amplifiers (OBA/OPA)

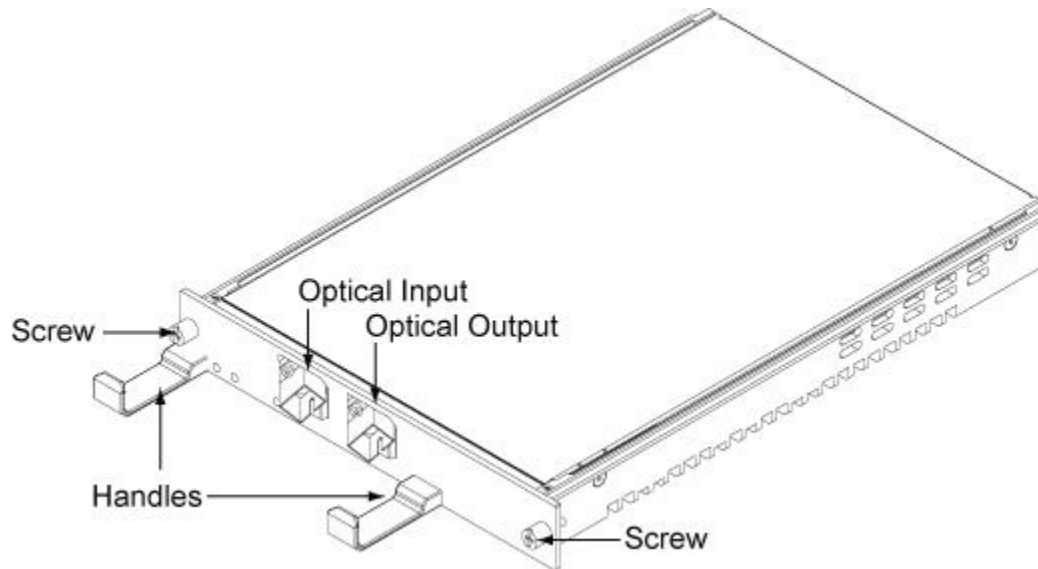
Figure 3-26 DWDM Optical Line Amplifier (OLA)

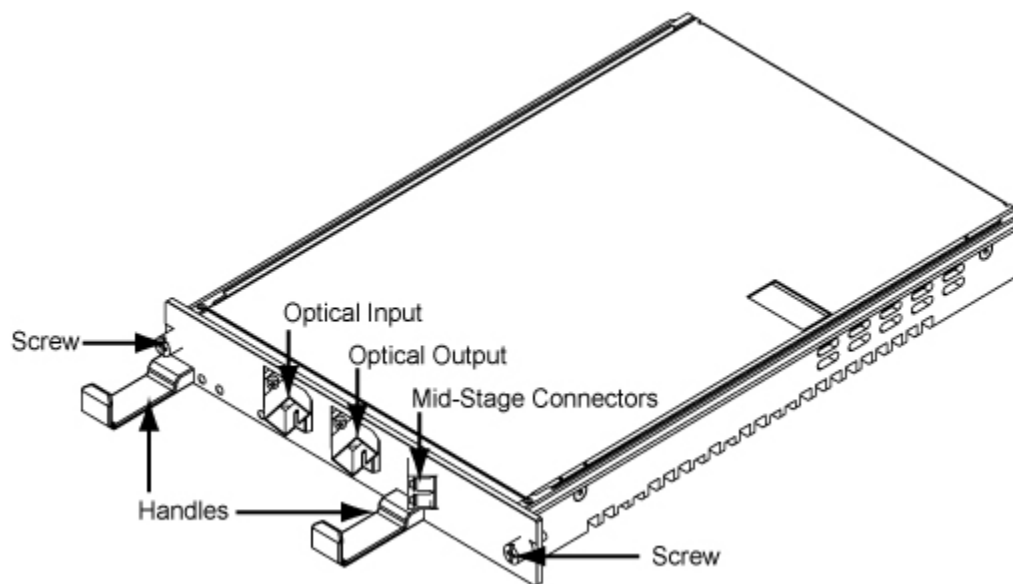
Figure 3-27 Optical Line Amplifier with Mid-Stage Access (OLAM)

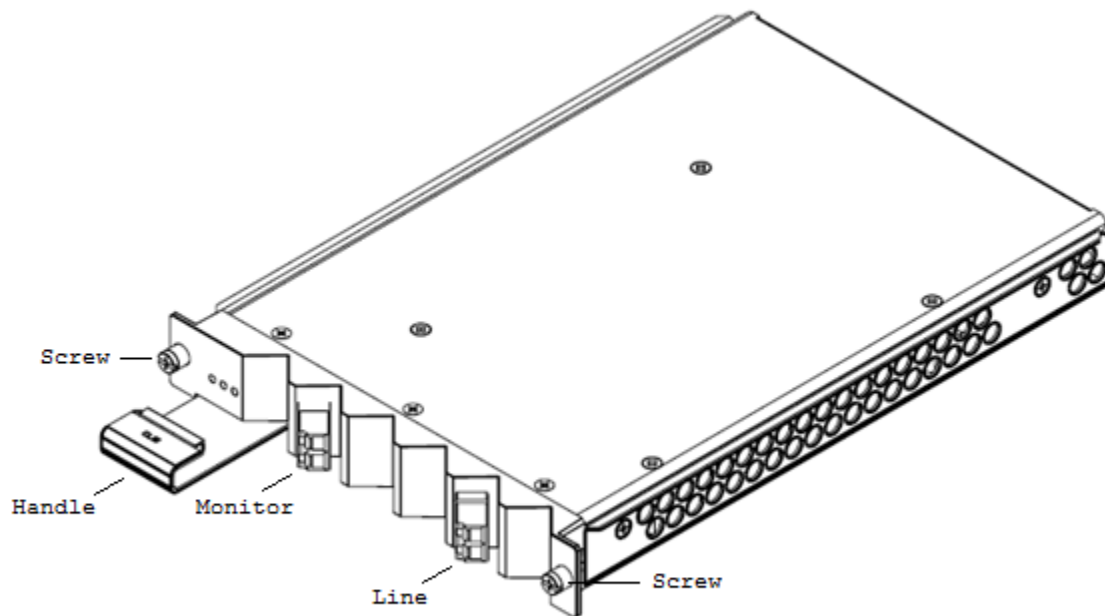
Figure 3-28 DWDM C-Band Low and Mid Gain Amplifiers (LGA/MGA)

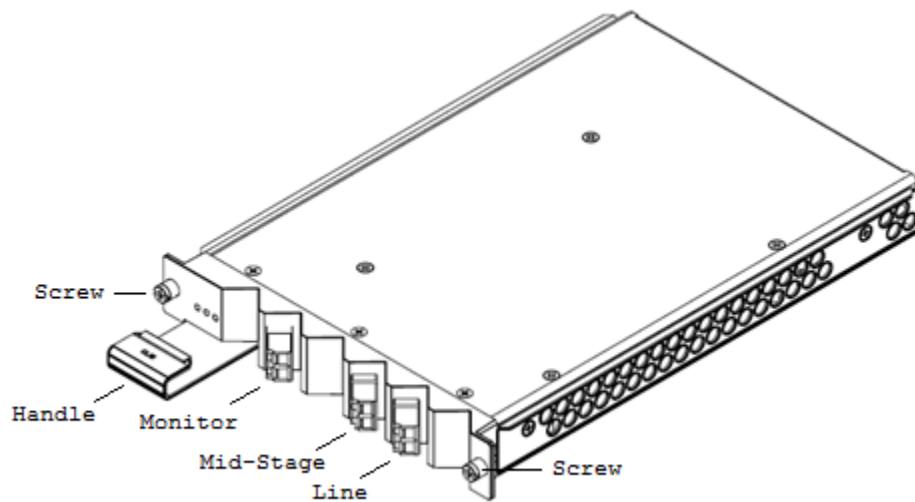
**Figure 3-29 DWDM C-Band Mid Gain Amplifier with Mid-Stage Access (MGM)**

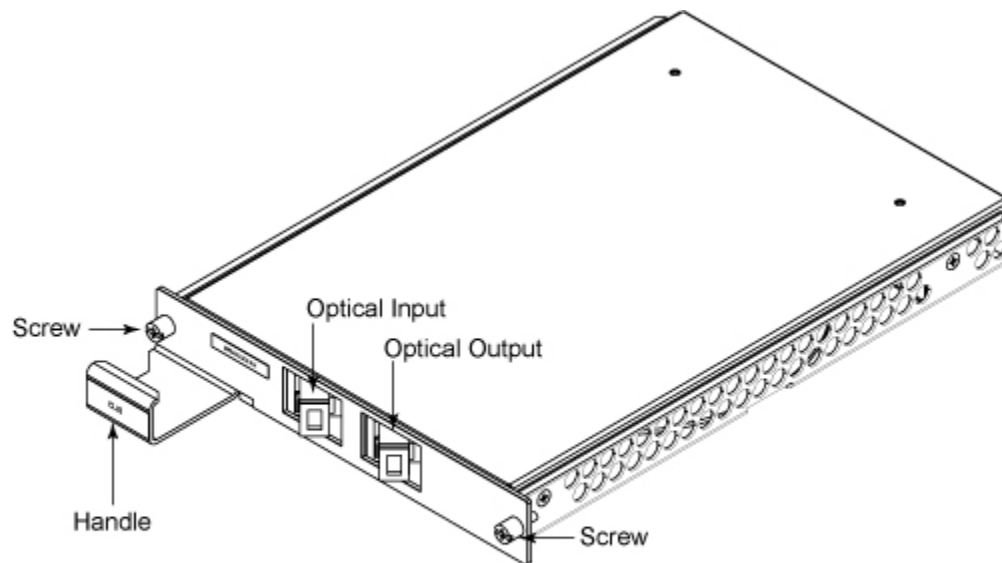
The following figure shows a DCM and indicates the key features for replacing it.

Figure 3-30 Dispersion Compensation module

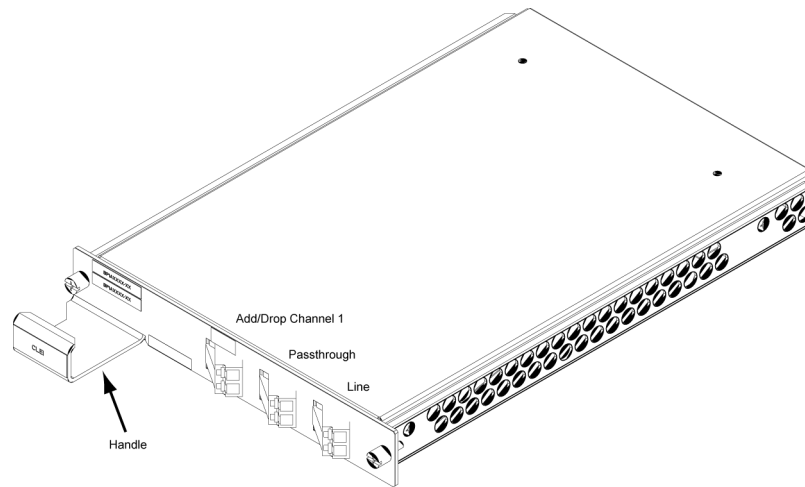
1-Channel OADM

The following figures show the key physical features of the 1-Channel, 2-Channel, and 4-Channel DWDM Optical Add/Drop modules.

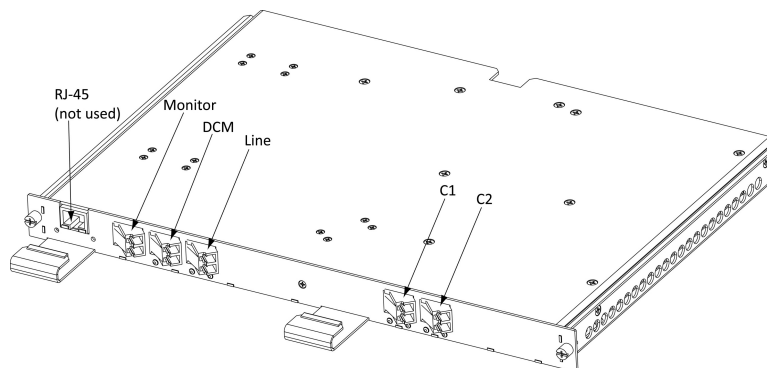
The following figure shows the 2D ROADM-on-a-blade (ROB2) module. The difference between the ROB2 and ROB4 modules is the ROB4 has two additional client ports—C3 and C4.

Figure 3-35 2DROADM-on-a-blade (ROB2)

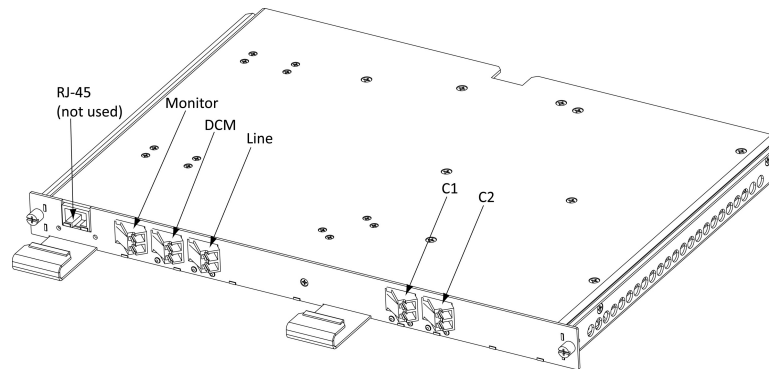
The following figure shows the ROB2 module. The difference between the ROB2 and ROB4 modules is the ROB4 has two additional client ports—C3 and C4. You do not use C3 and C4 for this type of module replacement.

Figure 3-36 2DROADM-on-a-blade (ROB2)

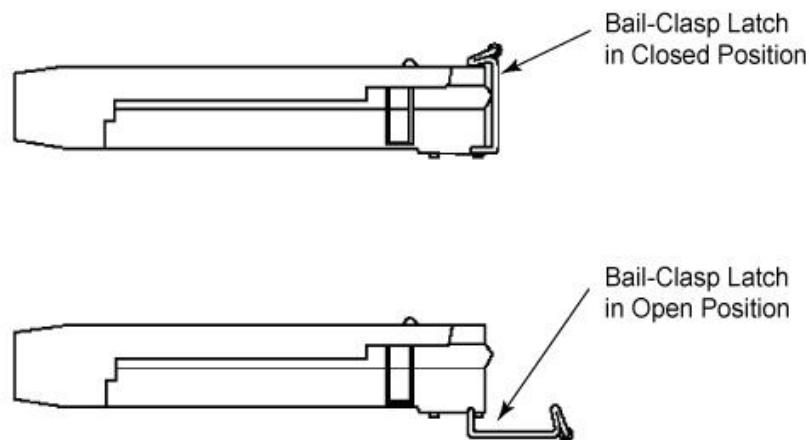
SFP transceiver with a bale-clasp latch

The following figure shows a typical SFP transceiver with a bale-clasp latch.

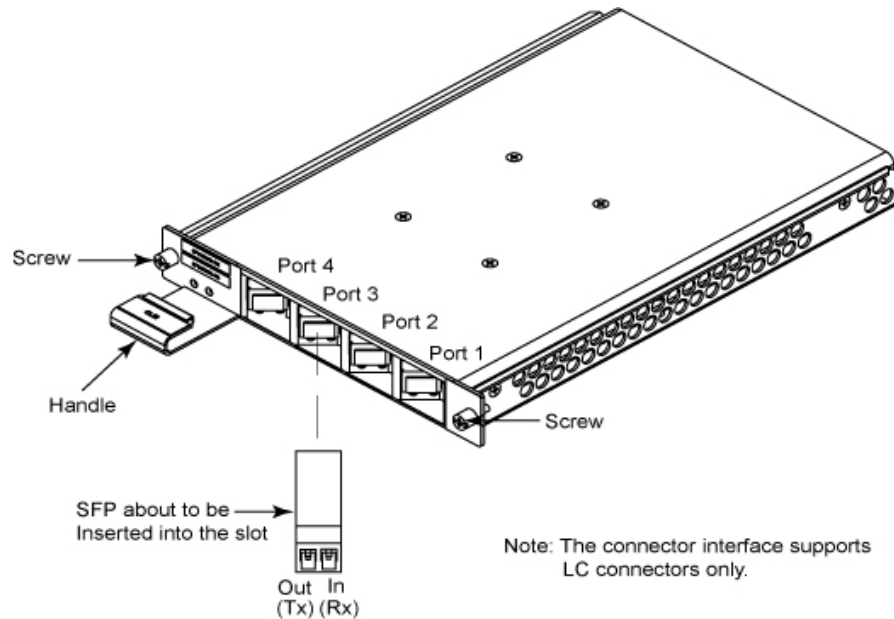
Transceiver insertion

The following figure shows an SFP transceiver about to be inserted into its slot in a generic module.
