BTI 7000 Series Alarm and Troubleshooting Guide

Part Number: BT7A74DA
Document Version: 01
Published: March 2017
Type: STANDARD

product release 13.5

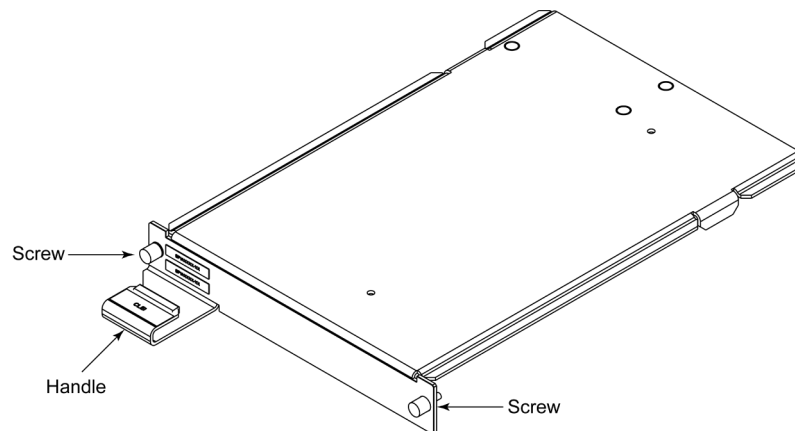
A single-width filler module and its key features for this procedure is shown in the following illustration.

Figure 3-39 Single-Width Filler module key features

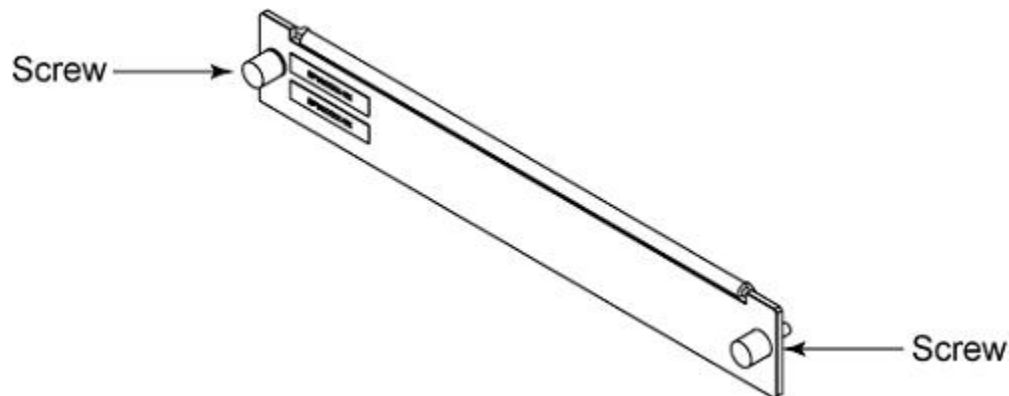
A single-width filler panel and its key features for this procedure is shown in the following illustration.

Figure 3-40 Single-Width Filler panel key features

Depending on the slot in which the filler is located, optical cables may need to be moved aside to get access to the panel. The cables rest on the handles that are at the front of the filler.

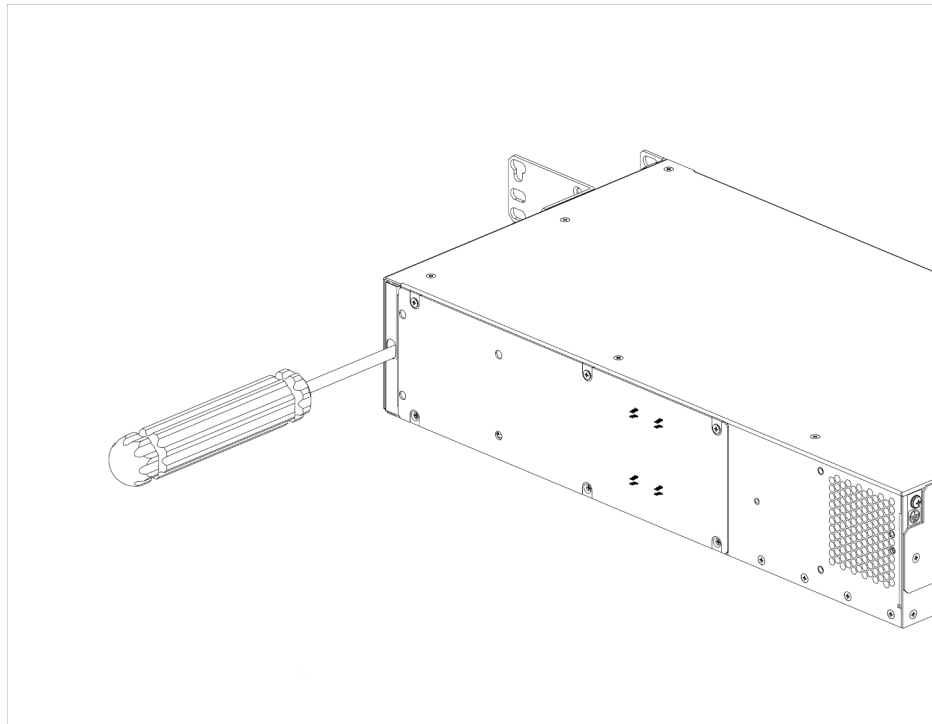
Step 1 The air filter cover is located at the rear of the BTI 7060 and is secured by a snap-on cover.

Using a slot-head or Phillips screwdriver, remove the snap-on cover.

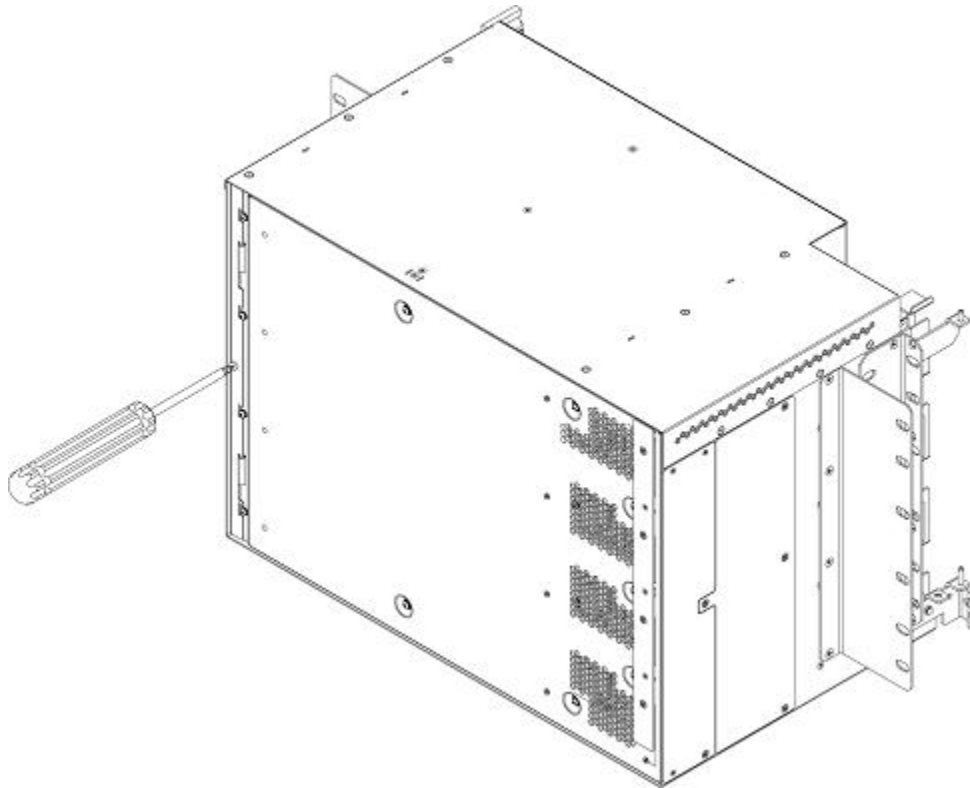
- Step 1** The air filter cover is located at the left rear of the BTI 7200 and is secured by a Phillips screw in the middle of the cover. The air filter may be covered by an air deflector. If so, remove it. See 3.16, “[Installing an air deflector on the BTI 7200](#)”.
- Step 2** Using a Phillips screwdriver, loosen the screw on the air filter cover until it is free to open.

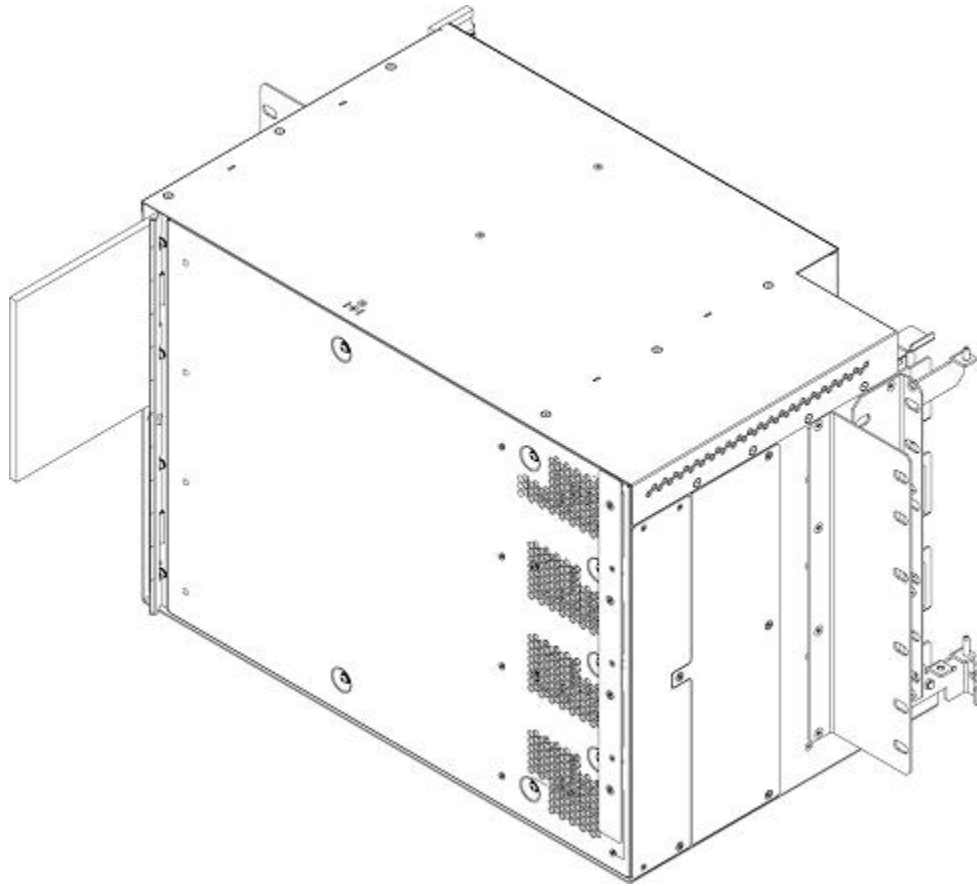
- Step 3** Facing the shelf, note that there are two air filter slots, upper and lower. If there is an air filter in either slot, remove and discard it.
- Step 4** Align a new air filter with one of the the slots.
Carefully slide the air filter straight into the slot.

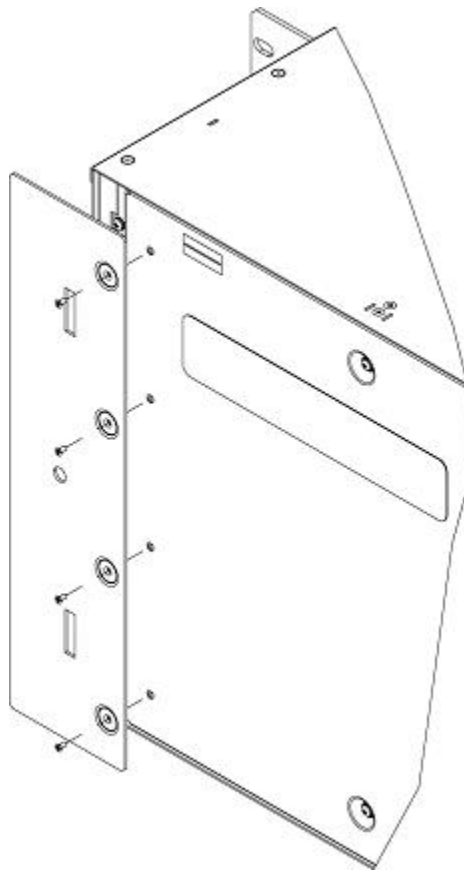
Step 1 The air deflector is located at the left rear of the BTI 7200 and is secured by four screws.

Using a Phillips screwdriver, attach the air deflector using the screws provided. The air deflector covers the air filter cover.
